## AUSTROADS

# Guide to Traffic Engineering Practice Part 7 - Traffic Signals

## ERRATA LIST

Prepared by R. Akçelik  
Akcelik & Associates

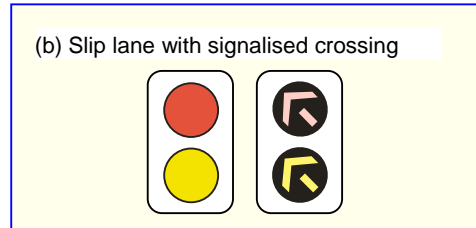
**Figure:** 5.6 (b)

**Error:** Second signal face should show red arrow rather than red circle.

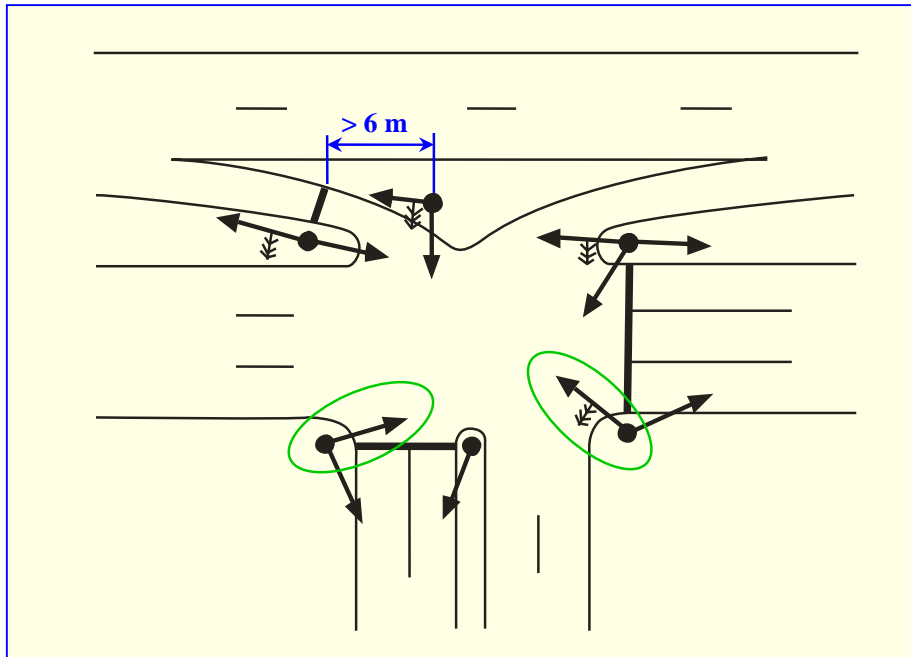
**Figure:** 7.7

**Note:** A Tertiary signal face added for East approach, and a Secondary signal face added for West approach (right turn).

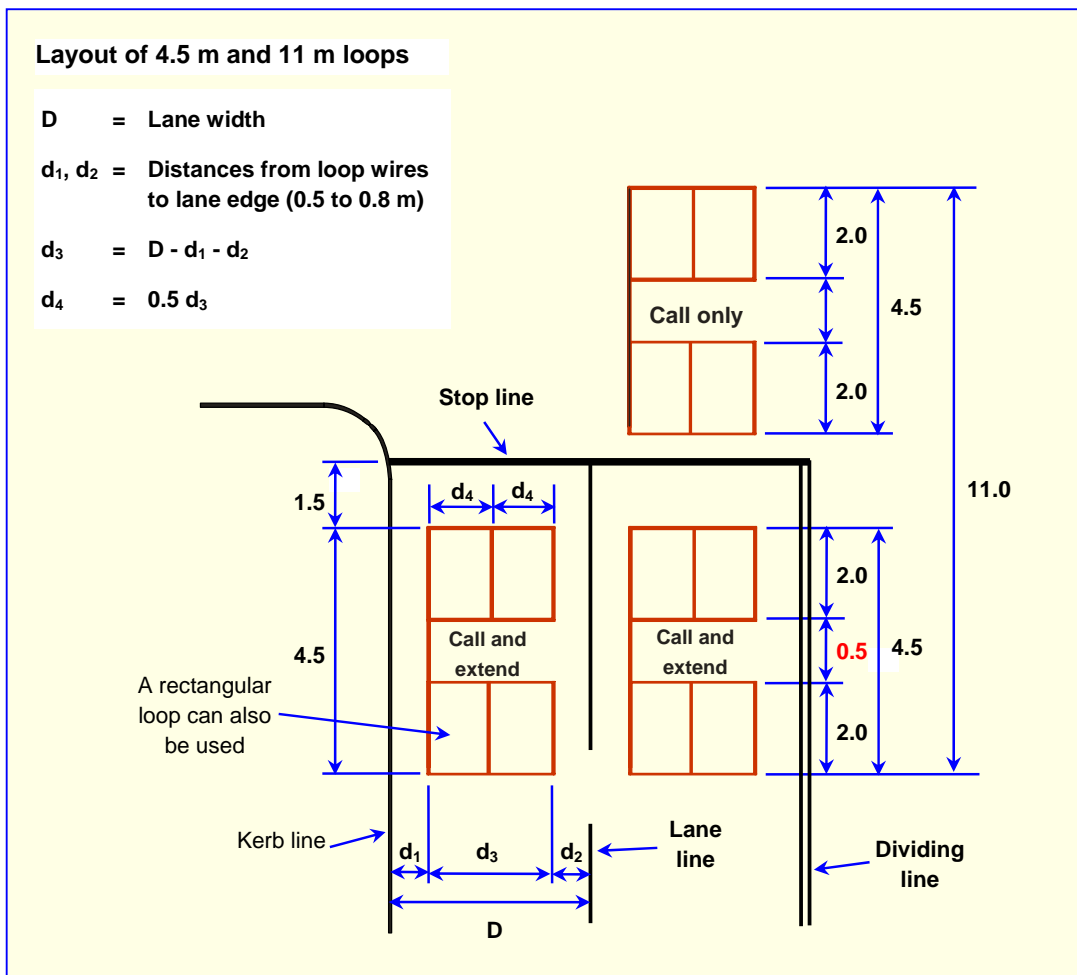
**Figure:** 8.3 (a)

**Error:** Gap between the two sections of the loop in the right-hand lane should be 0.5 m (not 2.0 m).

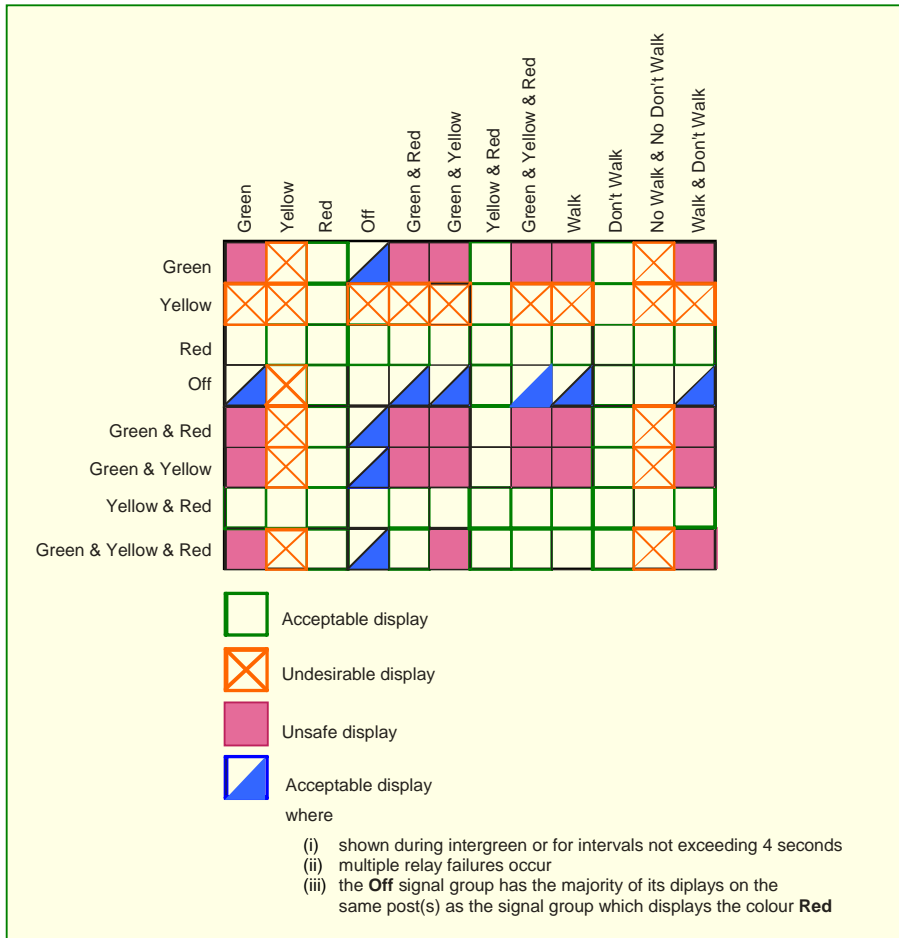
**Figure:** 9.2

**Error:** Acceptable display and undesirable display symbols are wrong. Correct figure is given below.

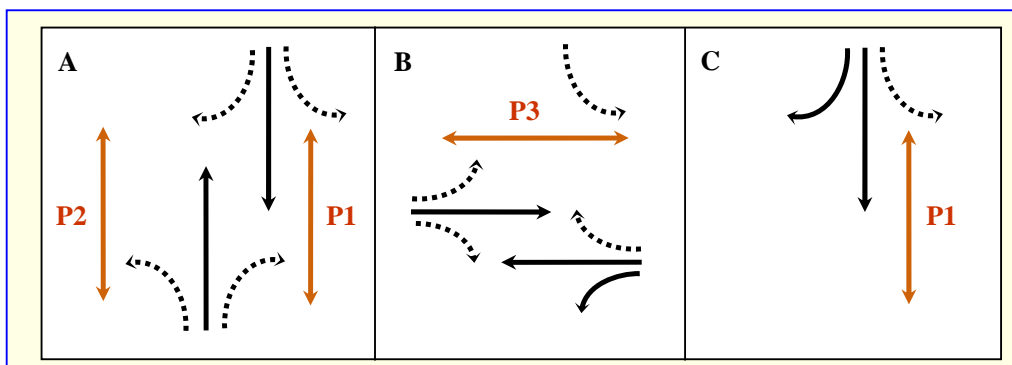
**Figure:** D.7

**Note:** Left turn movement in Phase C should be shown as a broken line due to pedestrian conflict.
