Stops & Goes of Traffic Signals

A Traffic Signal Auditors' Perspective

November 2004

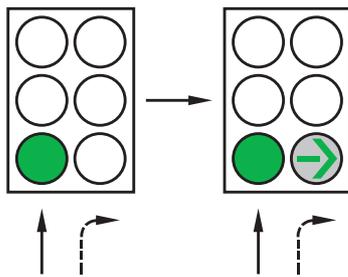
- 30% for filter right turns, followed by a right turn arrow (a lag right turn).

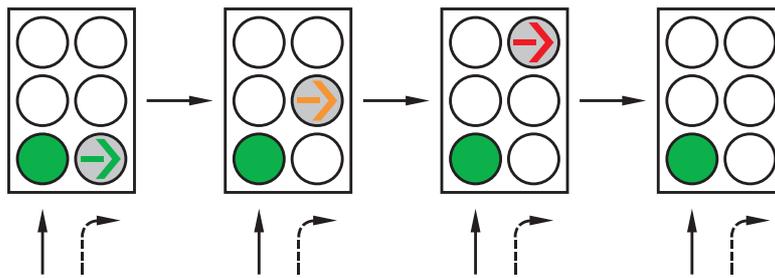
- 68% for a right turn arrow, followed by filtering (a lead right turn).

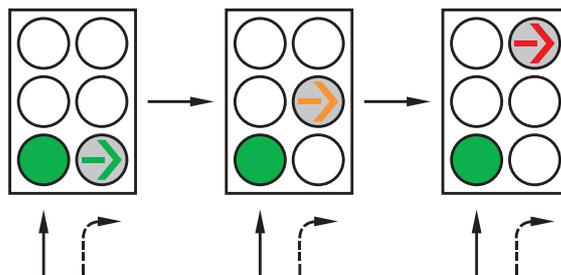
- 90% for a lead right turn, followed by a red arrow (no filter).

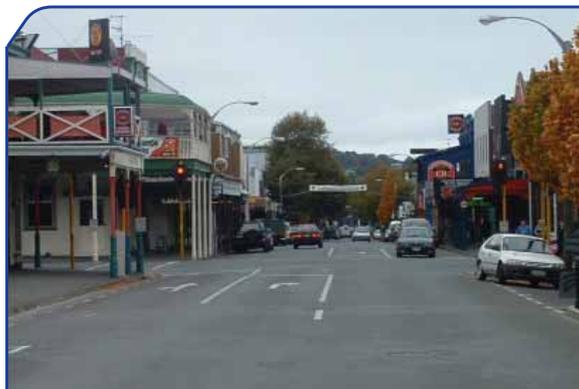
Figure 1 : Offset right turn bays (and hidden primary lantern).

Many 14 m carriageways had their two-lane shared approaches reconfigured to include an exclusive right turn lane, without relocating the centre line. This resulted in the opposed right turn lanes being offset.

- poor inter-visibility between right turners and opposing through traffic, resulting in a higher right-turn-against crash rate
- drivers concentrating too much on opposing through traffic, overlooking pedestrians or cyclists to whom they must also give way
- some drivers being hesitant, reducing intersection capacity
- increased inter-green time due to the longer tracking paths.

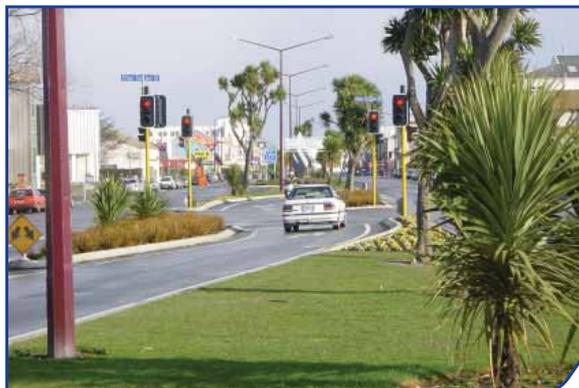
Figure 2 : Right turn bays incorporated into solid median achieving excellent forward-visibility.

- Ensure right turn bays line up (i.e. 'back to back' design).
- Reducing the right turn lane width minimises the offset between opposed right turners, further increasing forward-visibility.
- Where opposed right turn lanes are not possible (e.g. due to the inability to ban kerbside parking or tracking paths of vehicles), consider a different phasing operation (e.g. split approaches) or a right turn ban for one direction.

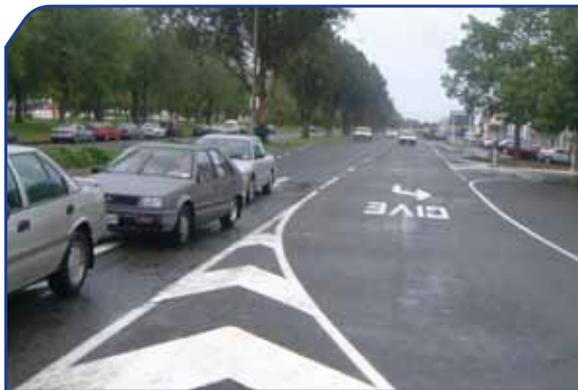
Figure 3 : Captive left turn lane with insufficient warning to motorists.

Captive turn lanes with insufficient warning were found quite frequently during the signal audits and they appear to be a result of the engineering plans not showing how to tie the intersection lane layout into the existing mid-block markings.

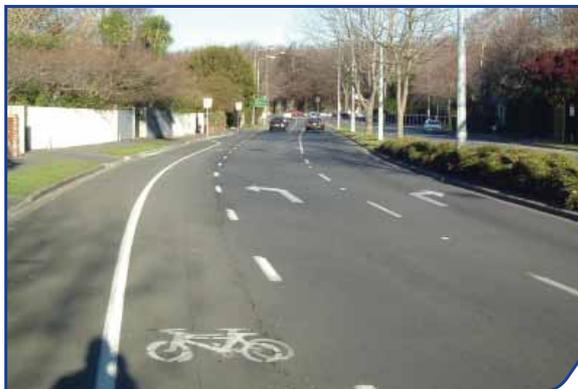
Figure 4 : Lane markings advising motorists of captive turn lanes.

- Channel drivers into through lanes whenever possible (ensure that engineering plans show the tie-in into the mid-block layout).
- Where captive lanes cannot be avoided (e.g. where two approach lanes in the mid-block lead into the stem of a T intersection with exclusive turning lanes), ensure that drivers have sufficient pre-warning by lane arrows and possibly signs.

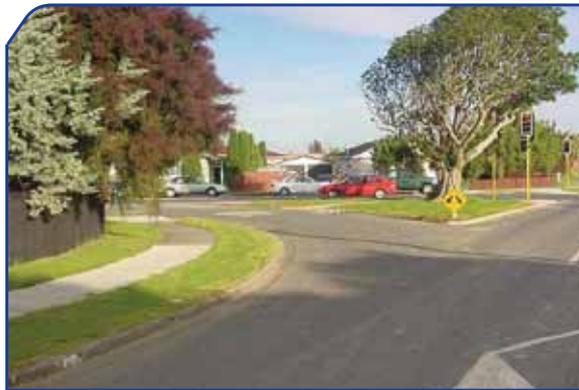
Figure 5 : Pedestrian crossing around the corner – poor visibility.

- Poor inter-visibility between pedestrians and left turners, if the crossing position is too far around the corner.
- Drivers having problems observing traffic to give way to if the slip lanes are not of the high-entry angle type, or if the kerb radii are too large (because some people have problems turning their heads and door pillars may obstruct visibility). Driver hesitance and increased crash rate are possible consequences.
- Increased turning speeds, resulting in loss of control or failure to give way.
- Not enough room for pedestrians (e.g. during the school peak) or street furniture, if islands are undersized.

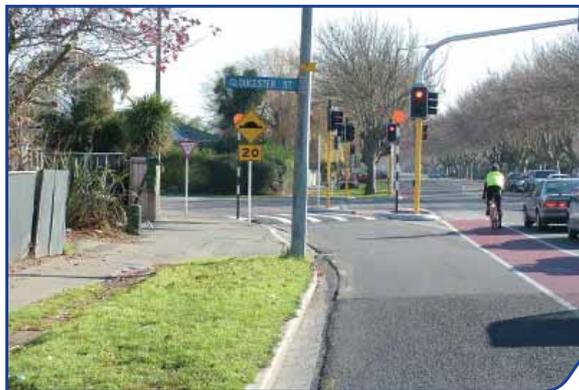
Figure 6 : Slip lane with zebra crossing on raised platform for speed control.

- Slip lanes should be of appropriate size and of a high-entry-angle type, with adequate corner radii.
- The location of the pedestrian crossing point should provide sufficient intervisibility.
- Pedestrian priority issues can be addressed using a signalised slip lane crossing, or a priority (zebra) crossing (possibly on a raised platform).

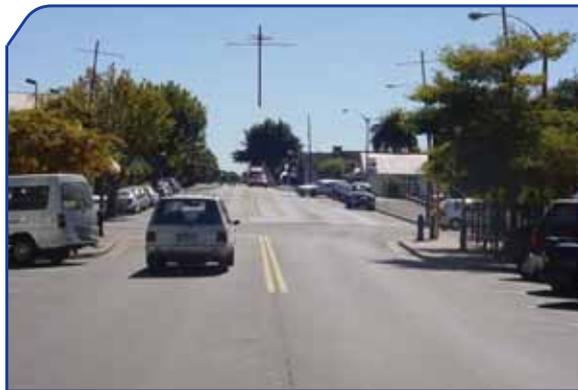
Figure 7 : No signals visible to approaching drivers.

One of the most common safety audit findings was that of signals with inadequate conspicuity. When this lack of conspicuity includes the signal faces that perform the warning and stopping functions, safety is reduced as a consequence.

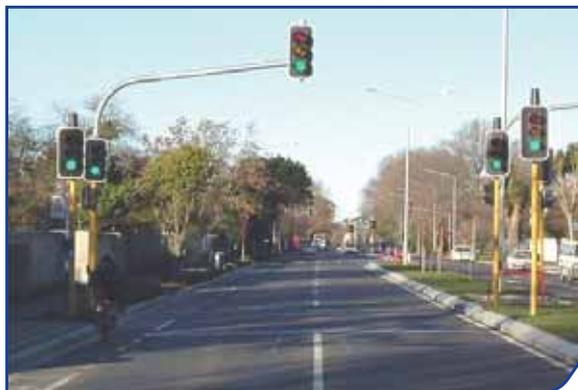
Figure 8 : Good conspicuity of traffic signals.

- RCAs should have an upgrading programme for conversion to tall (5 m) posts or mast arms as appropriate.
- Kerbside posts should be located nominally 1 m (and no less than 0.6 m) from the kerb face, and close to the tangent point. Minimising corner radii can help achieve this.
- Kerb extensions should be used wherever possible to improve lantern visibility.
- Street furniture should not reduce signal conspicuity. Under-grounding aerial services, locating street lighting poles at the property boundary, and the use of joint-use poles can all be considered. The size of trees must be taken into account both at the time of planting, and at maturity, and on-going maintenance (pruning, trimming) allowed for.

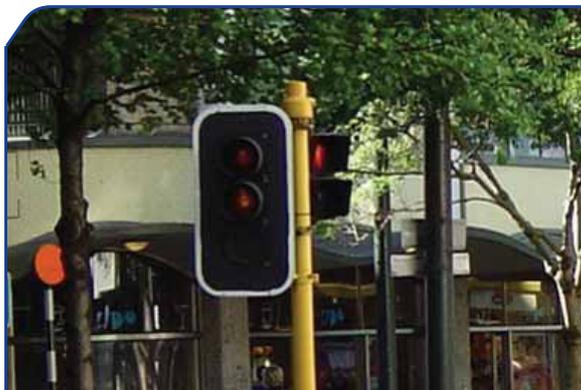
Figure 9 : Non-complying two-aspect display (green missing).

- At a minimum, all displays must be provided in the primary or dual primary position (including arrow displays).
- The minimum number of signal displays for major and minor movements is three and two, respectively. A right or left turning movement that is (at least partially) allowed to filter is a minor movement, and a right turning movement that is fully protected is classed as a major movement.
- On multi-lane approaches, one signal face is sufficient for two lanes only.
- At least one aspect must be illuminated in any one signal face at any one time (i.e. avoid signal faces with three arrow aspects only where filter turning occurs, as all aspects will be in the OFF state during filter turning).

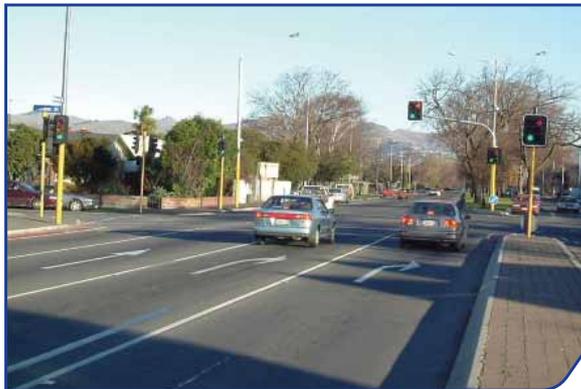
Figure 10 : Fully protected right turn with the required three right turn arrow displays.

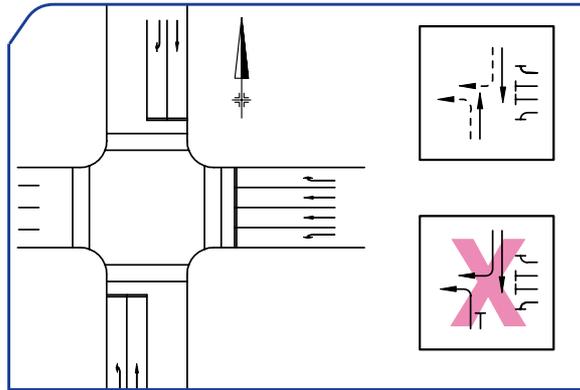
Figure 11 : Bad practice of allowing protected turns into their own lanes simultaneously.

- A protected turn phase can only be operated when there is no conflict. It is not considered good practice to have protected but opposing movements turn into their respective nearest lanes (i.e. a left turn green arrow and an opposing right turn green arrow should not be displayed together unless the departure lanes are physically separated by means of a solid island)

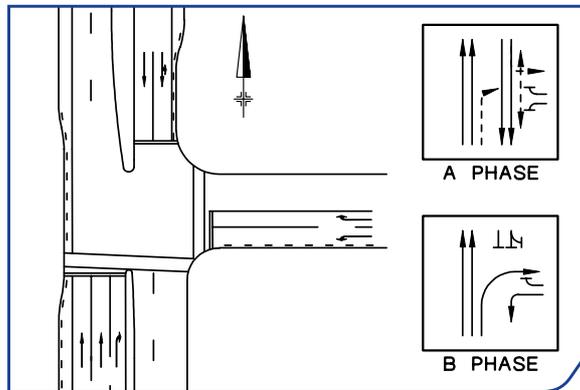
Figure 12 : Avoid a 'right turn trap' for u-turners on the north approach by either banning that u-turn, or by ensuring that A phase is never followed by B phase.

Particular care must be taken to avoid phasing an unintentional lag right turn when the opposing right turn movement may filter-turn. This 'right-turn trap' happens when a filter right turner (or a u-turner at a T intersection) faces a yellow circle display, but the opposing through movement overlaps to a lag right turn phase. The right turner (or u-turner at a T intersection) has no indication whatsoever that the opposing through movement is not being terminated and may turn during the amber believing the opposing through movement is stopped. This situation can occur when intervening phases are skipped, e.g. during low demand periods.

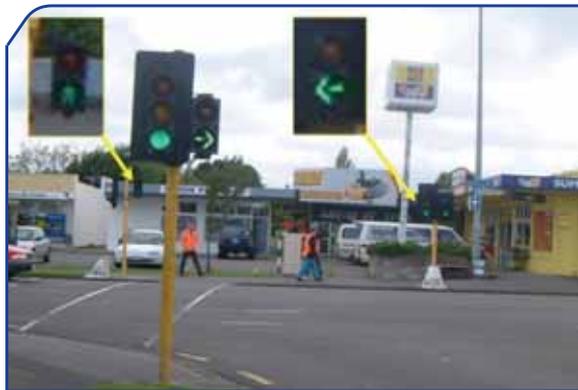
Figure 13 : Non-complying green left turn arrow, as Walk is displayed simultaneously.

Where an opposing right turning movement is held on a red arrow, a green left turn arrow (when present) should indicate to approaching motorists that they have priority over the opposing right turn movement. This is especially important when the opposing movement is allowed to filter turn some of the time in which case the left turn display should be in the OFF state.

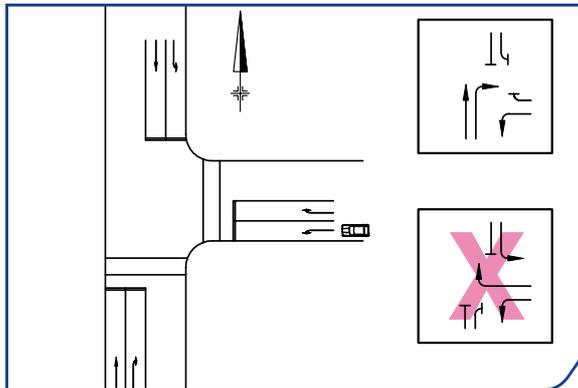
Figure 14 : A left turn demand on the side street should call the associated main road right turn phase.

When a left turn is associated with a right turn phase, it is good practice for the left turn detector to also call the right turn phase. This results in greater efficiency as just one of the main road approaches needs to be stopped whenever there are only left turn vehicles.

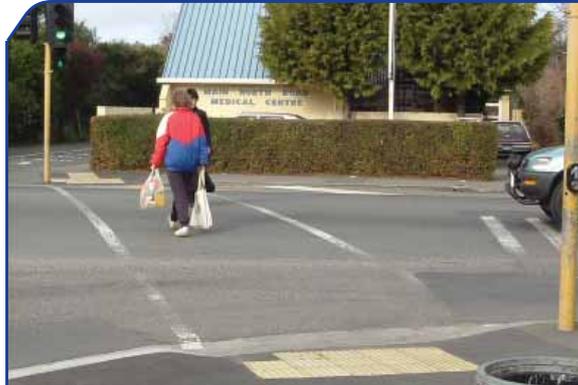
Figure 15 : Bad practice of providing a crosswalk to the right of the side street at a T intersection without pedestrian protection.

- Unless full pedestrian protection is used, it is not good practice to provide a crosswalk that right turners from the stem of a T junction have to cross.

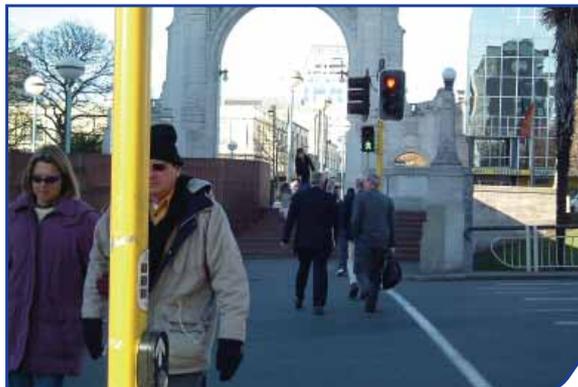
Figure 16 : A late start of the vehicle phase provides pedestrian protection at this T intersection.

- If pedestrian protection is deemed warranted, but no arrow displays exist, it is acceptable to provide a late start for the parallel vehicle phase (generally about 3 sec).

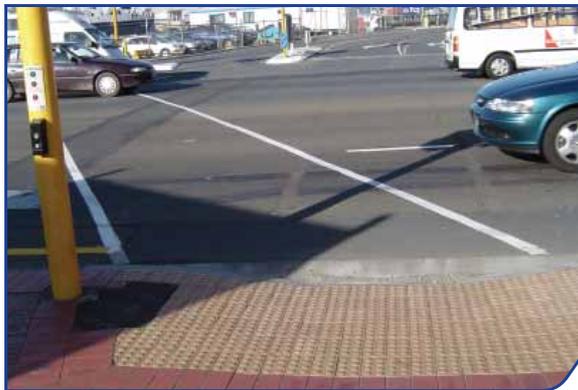
Figure 17 : Visually impaired pedestrians are directed away from the crosswalk by the warning paver layout. Tactile pavers should be laid at the same angle as the crosswalk.

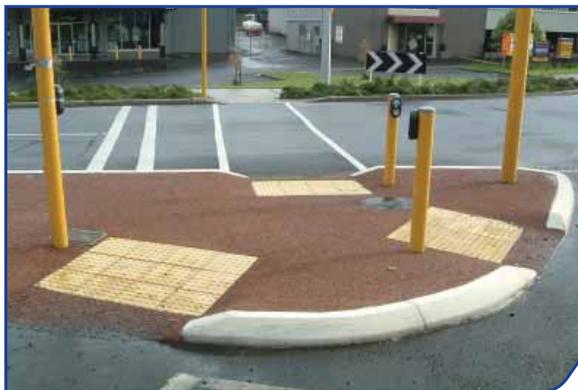
Figure 18 : Use of stub post for appropriate placement of pedestrian call box adjacent to the pram crossing¹.

¹ Note the stub post on the far side of the island is placed on the wrong side of the crosswalk.

- Install push buttons at the cut-down. Make use of short stub posts if the signal post is not in a suitable location and cannot or should not be shifted.
- Ensure that the embossed arrow and any tactile paving are orientated correctly.
- Avoid safety rails obstructing push buttons.
- Ensure audio-tactile equipment for adjacent crosswalks is at least 3 m apart.
- Ensure the recommendations of RTS 14 are followed.

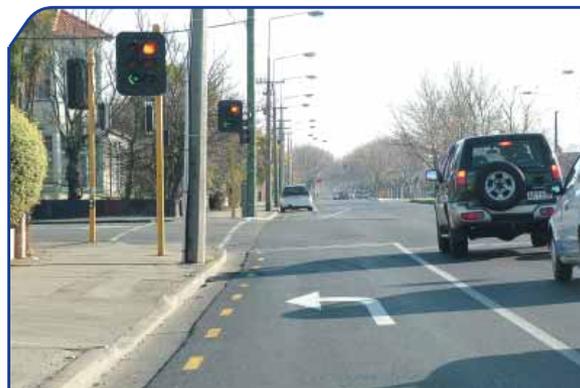
Figure 19 : No safe and legal waiting position for straight-through cyclists during left turn only phase.

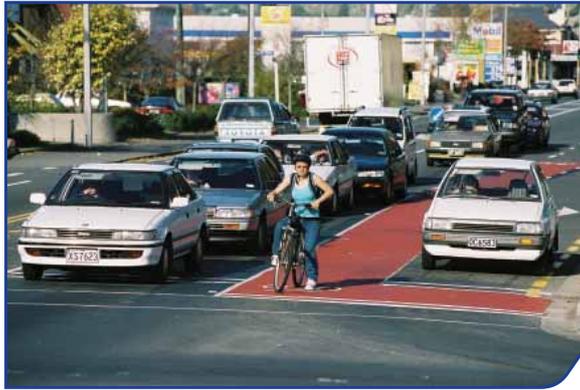
Figure 20 : A good example of providing for cyclists at traffic signals.

- Aim for a treatment that is as far as possible suitable for cyclists with basic competence.
- All normal manoeuvres should be possible (including the option of a hook turn).
- Manage conflict between left turning motorists and straight through cyclists. Slip lanes are a good tool for this.
- Achieve an intuitive layout so that motorists and cyclists know where they are expected to be on the road. Colouring the cycle lanes at the intersection will support this.
